Caley Valley Wetlands

Preliminary assessment of impacts to Caley Valley Wetlands from Abbot Point Coal Terminal post Tropical Cyclone Debbie.

July 2017

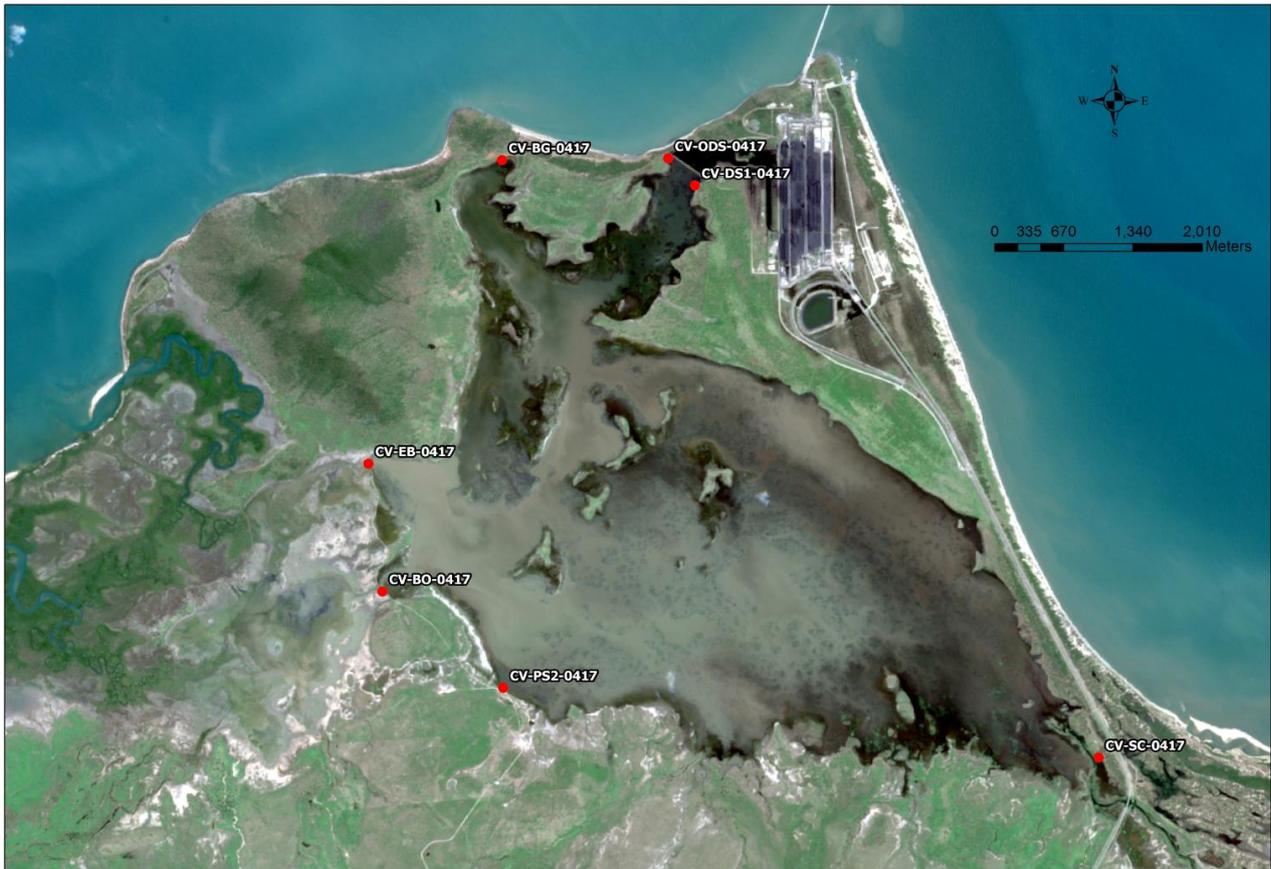
Figure 2: Copernicus Sentinel-2 satellite image (11 April 2017) of Caley Valley wetland and sediment sampling locations. The image is displayed as a true colour composite with bands 4, 3 and 2 assigned respectively to the red, green and blue colours. The satellite image was used to help identify sampling locations.

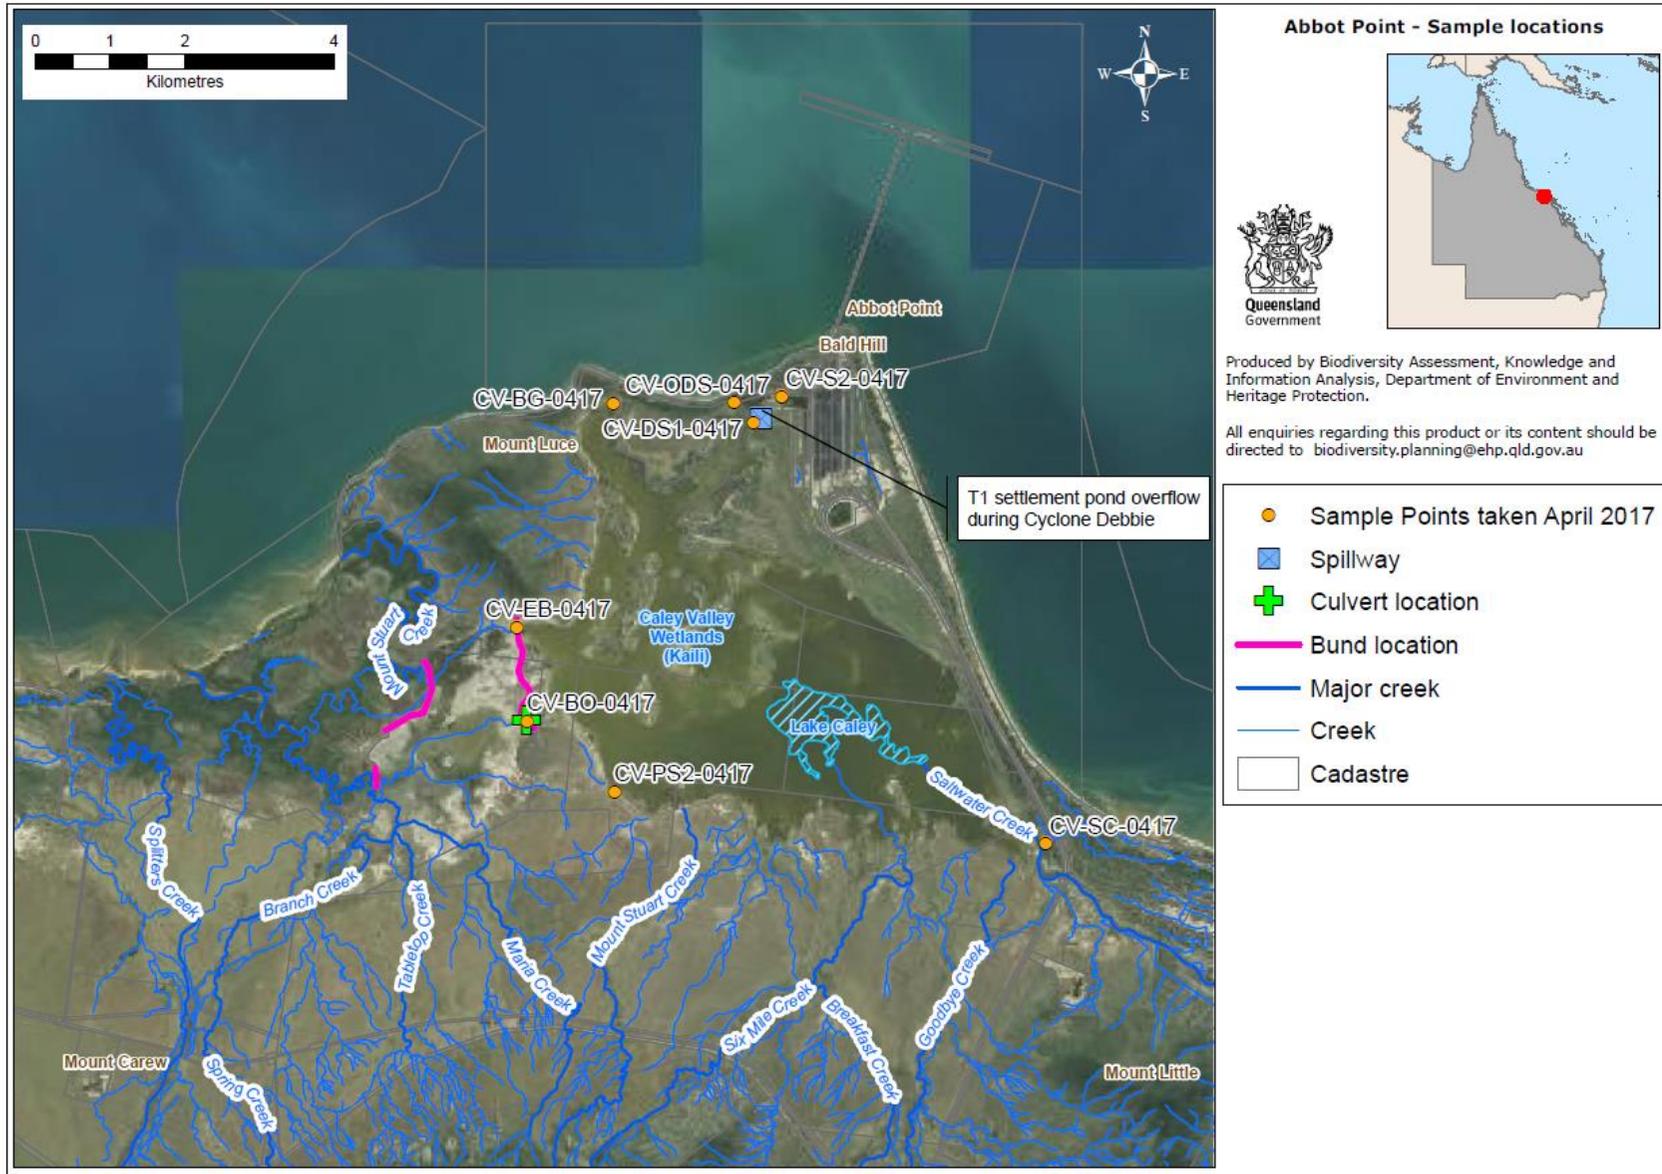
Figure 3: Sites sampled on 27 and 28 April 2017 in the Caley Valley Wetlands by DSITI and EHP staff.

- CV-S2-0417. Secondary settlement pond on the Abbot Point terminal site, immediately upstream of spillway and authorised release point W1. Sample collected from edge of the settlement pond.
- CV-DS1-0417. Site immediately downstream of authorised release point W1.
- CV-ODS-0417. Site on the opposite end of the spill way to CV-DS1-0417.
- CV-BG-0417. Site on western arm of the freshwater wetland, not immediately downstream of the spillway runoff.
- CV-EB-0417. Site on northern end of eastern bund.
- CV-BO-0417. Site at outflow pipe on southern end of the eastern bund.
- CV-PS2-0417. Southern site near known painted snipe sightings.
- CV-SC-0417. Site in Saltwater Creek.

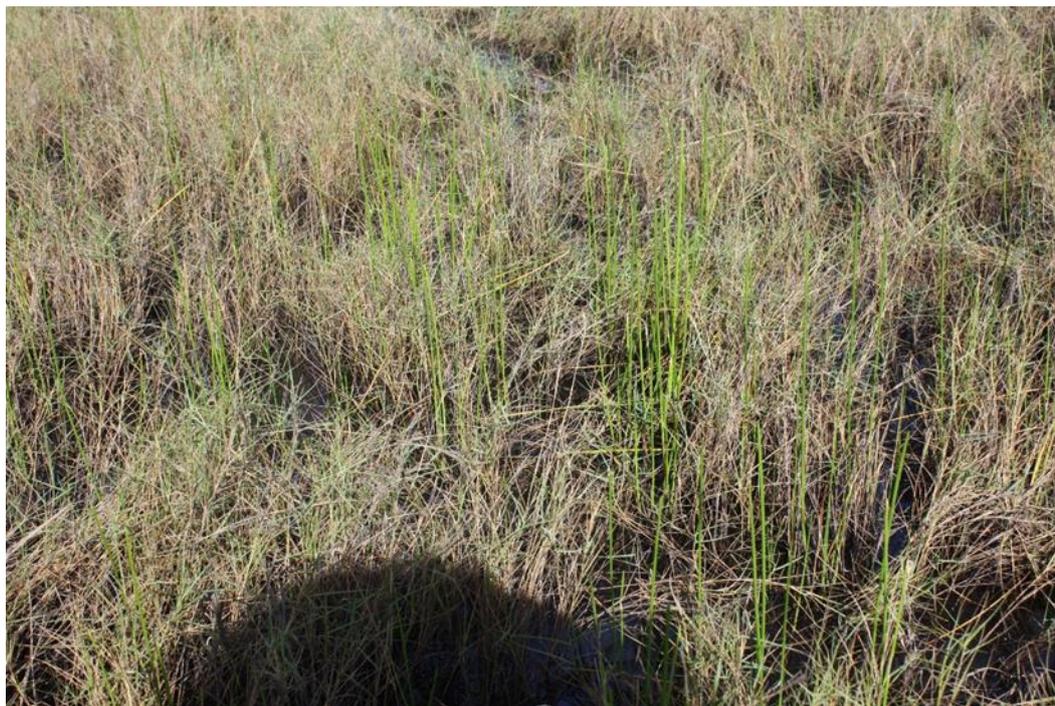
Although there was evidence of discolouration and what appeared to be coal residues, there did not appear to be any impediment to growth of wetland plants such as mangrove clubrush (*Schoenoplectus litoralis*), which is responding (i.e. emerging as new growth) to the recent flooding (Figure 4).

Figure 4: Mangrove clubrush (*Schoenoplectus litoralis*) is the bright green emerging reed in this photo at site CV-DS1-0417.

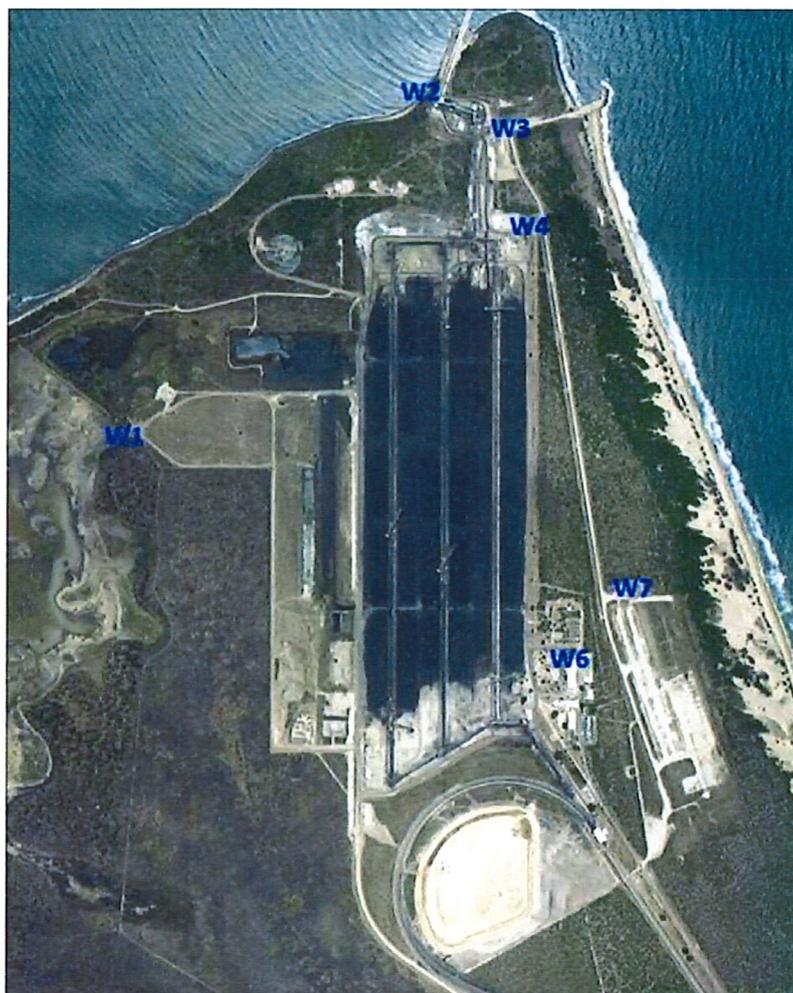
W1	Discharge Point from the Secondary Settlement Pond
W2	Sample Plant Water Drain
W3	Land adjacent to the Surge Bin sediment sump
W4	Land adjacent to the Main Sub Station sediment sump
W6	Outflow from the oil/water separator from motor vehicle workshop
W7	Outflow from the final holding tank of the sewage treatment plant

Figure 1: Contaminant Release Point – W1 and W2 for this TEL.

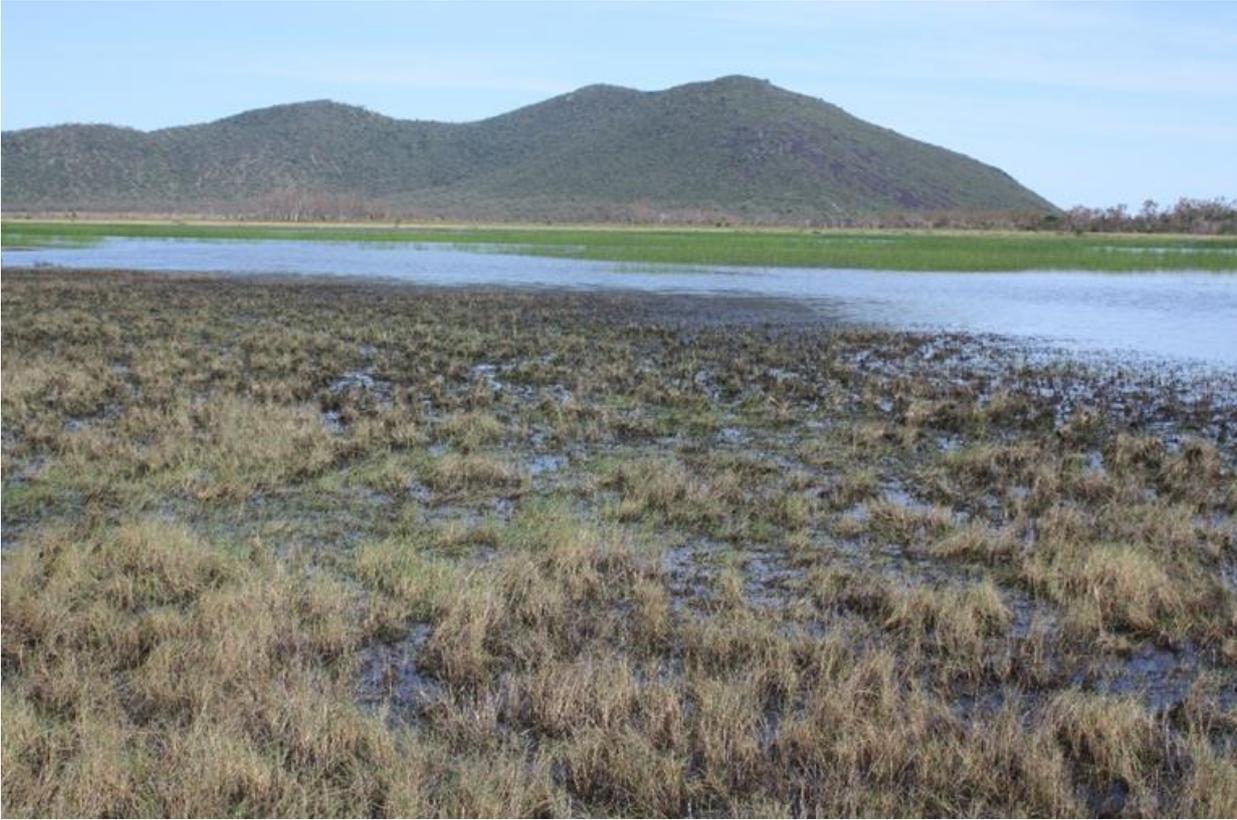
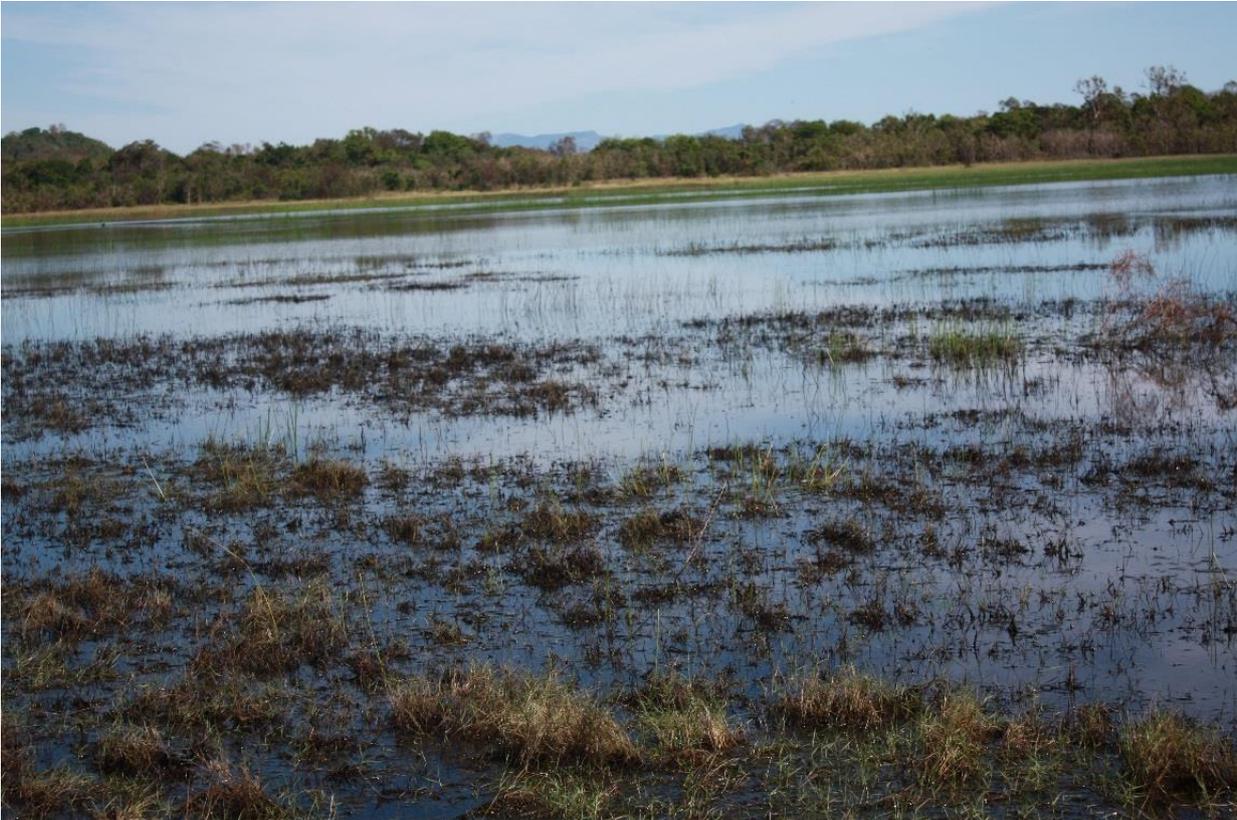
CV-DS1-0417

Coal residues were only observed at a site downstream of the licensed discharge point (CV-DS1-0417). It is not unexpected that an accumulation of the coal fines would be present at this site. This may be associated with the authorised release of settlement pond water into the wetland, which was reported to have up to 80 mg/L of suspended solids, and below the TEL limit of 100 mg/L.

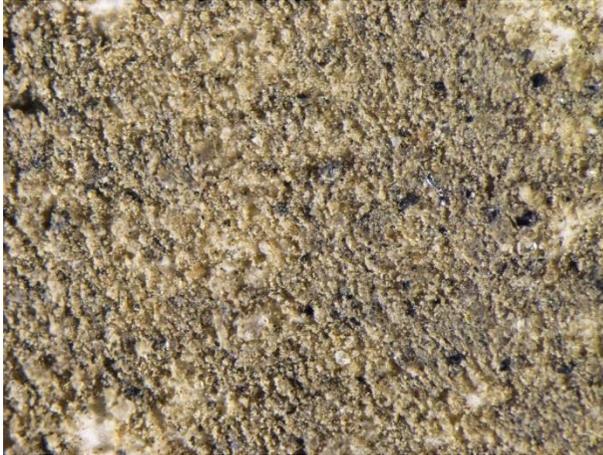
StMPM1. CV-DSI-0417, UQMP # 14907. Very small dark brown to gold coloured particles with a number of black angular particulates, typical of coal noted and dispersed through out the deposit.

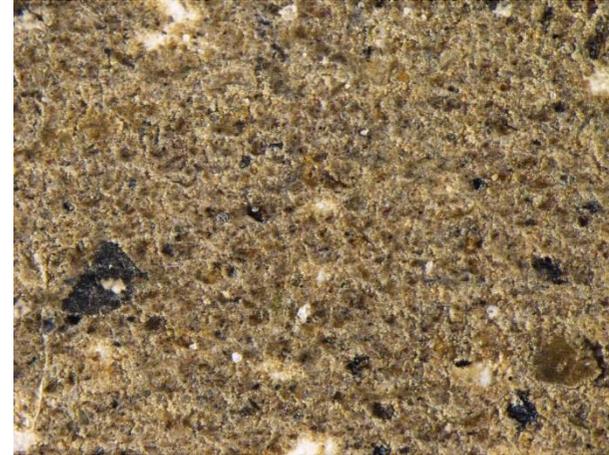
StMPM2. CV-BG-0417, UQMP # 14908. Predominantly a brown deposit with a small number of dark particle present.

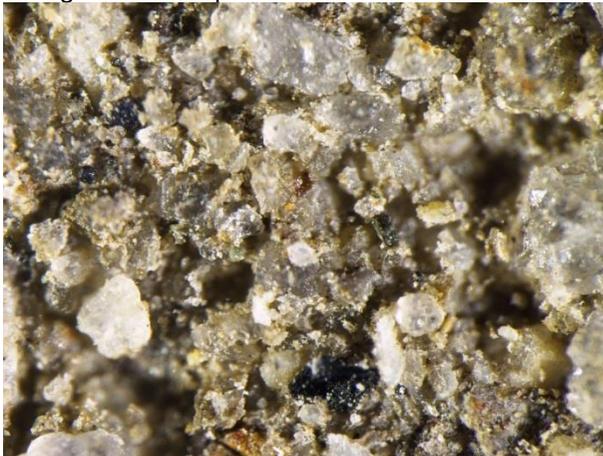
StMPM3. CV-ODS-0417, UQMP # 14909. Coarse grained particles with a range of colours from white to brown with a few black angular particles in the field of view.

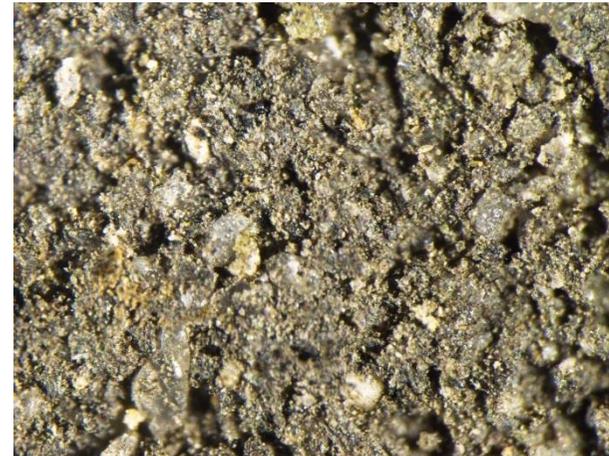
StMPM4. CV-S2-0417, UQMP # 14910. A few coarse particles with very fine particles dispersed throughout the deposit predominantly light brown with some gold coloured and translucent particles.

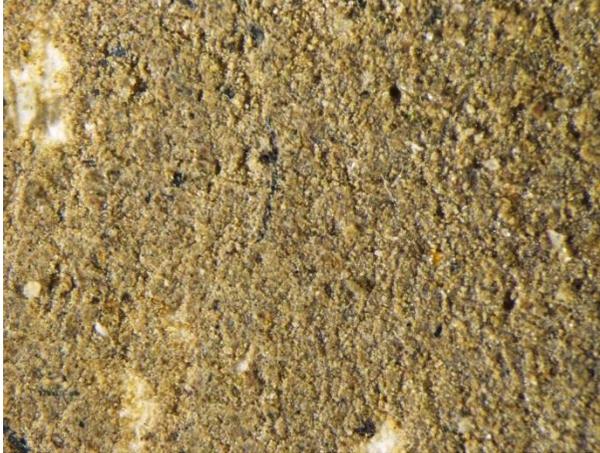
StMPM5. CV-SC-0417, UQMP # 14911. Very fine grained particles predominantly light brown to gold in colour.

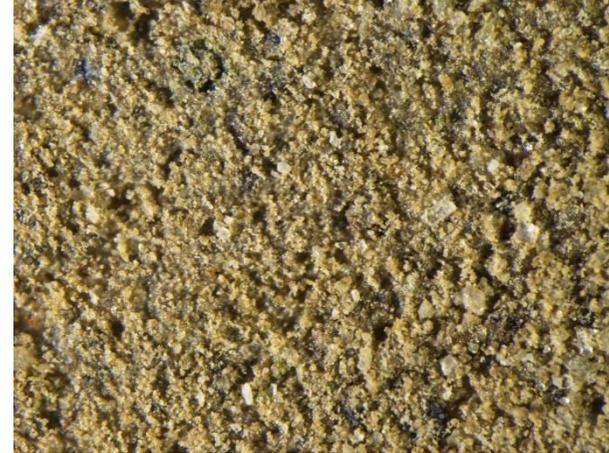
StMPM6. CV-BO-0417, UQMP # 14912. Medium grained particles predominantly light brown to gold in colour.

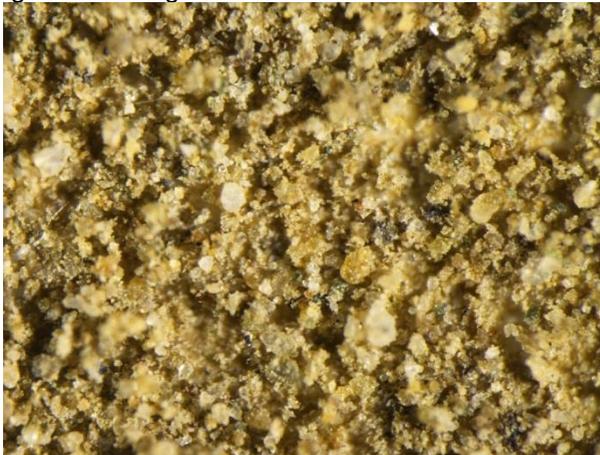
StMPM7. CV-EB-0417, UQMP # 14913. Coarse grained particles with particles mostly light brown to gold with a few translucent particles scattered throughout.

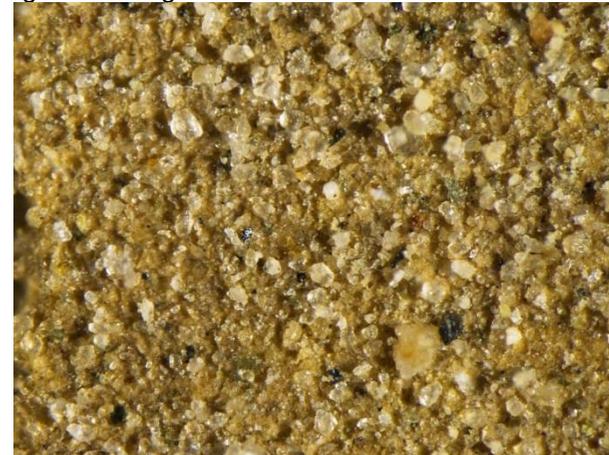
StMPM8. CV-PS2-0417, UQMP # 14914. Coarse grained particles mostly light brown to gold with a few translucent particles throughout the deposit.

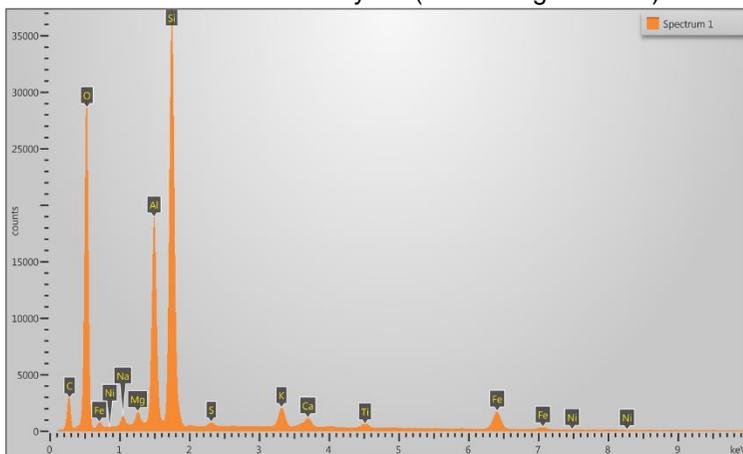
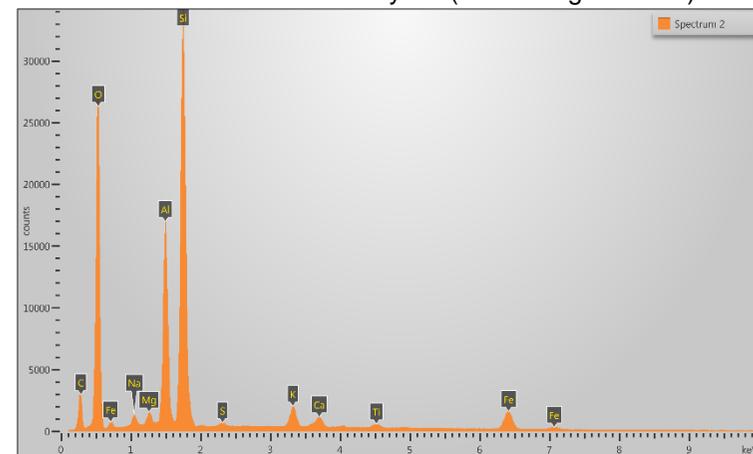
EDS1. CV-DSI-0417, UQMP # 14907. The SEM/EDS spectrum of the overall area displays major peaks of carbon, oxygen, aluminium and silicon with minor amounts of potassium and iron and trace amounts of the balance of the elements. This elemental profile is consistent with observations a deposit consisting predominantly of mineral dust.

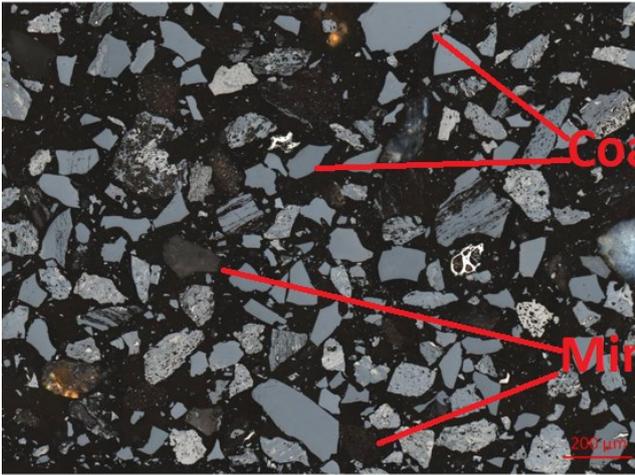
Figure 2a: Optical photomicrograph collected in reflected light using an oil immersion objective of a sample containing coal and mineral particles

- For these two samples, the ALS Coal microscopic method reported significantly more coal than did the other two methods. One reason may be that ALS Coal performed these analyses using the method described in AS2856.2, where immersion oil is placed on the polished surface of the block and the analyses are undertaken using an oil immersion objective. The immersion oil is used as it provides significantly more contrast between the different coal constituents. However, as some of the minerals have a similar refractive index to that of the immersion oil, it is often difficult to identify the liberated mineral particles in the sample. This is demonstrated below in Figure 2.

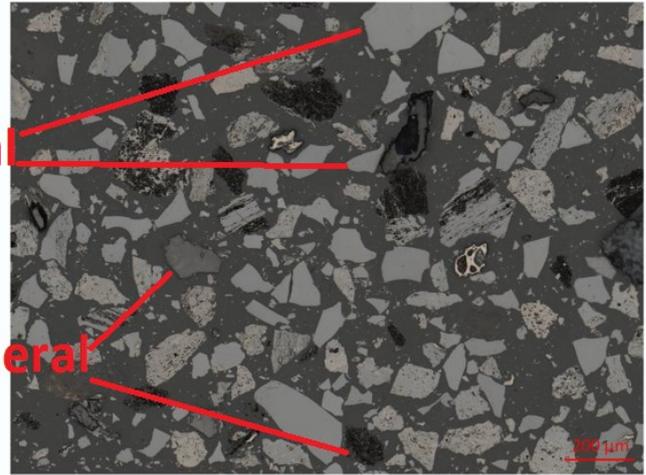
Figure 2b: Optical photomicrograph collected in reflected light using an air objective of a sample containing coal and mineral particles

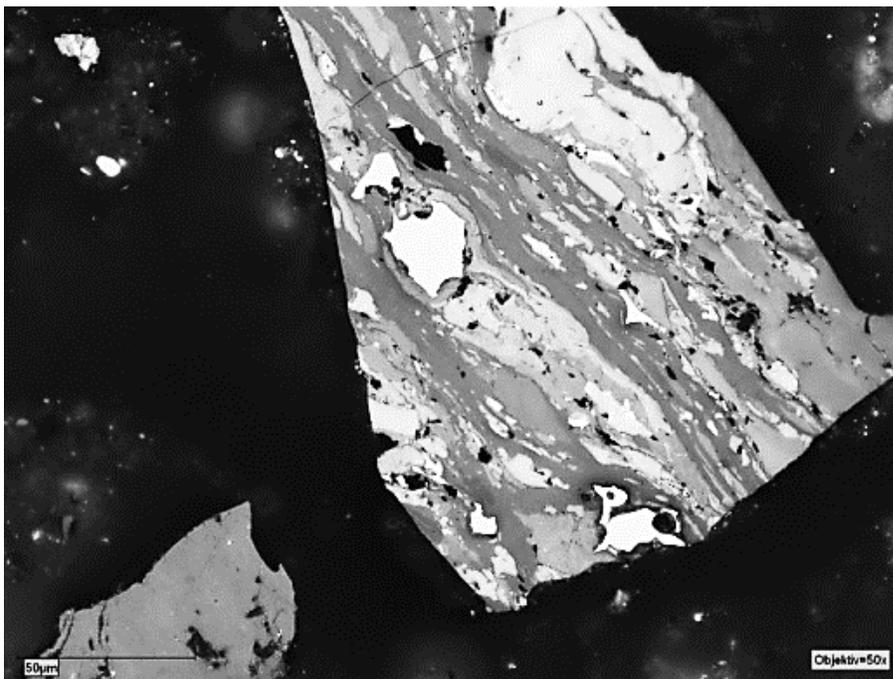
Figure 1: A coal dust particle, with the darker grey Vitrinite and lighter grey/white of Inertinite; 50x objective, oil immersion, reflected white light.

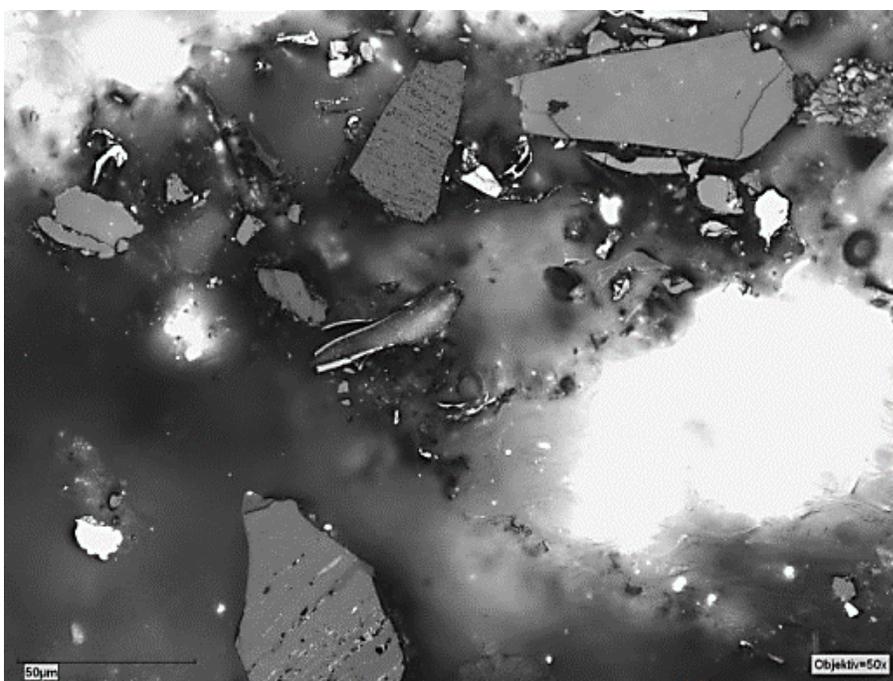
Figure 2: A cluster of Vitrinite grains and some interspersed minerals; 50x objective, oil immersion, reflected white light.

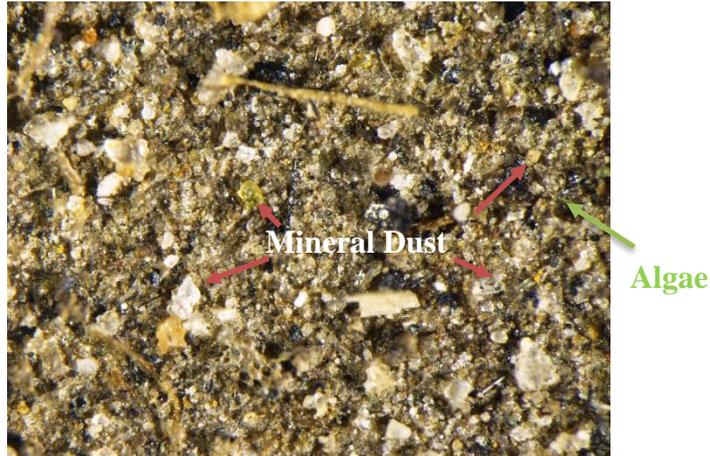
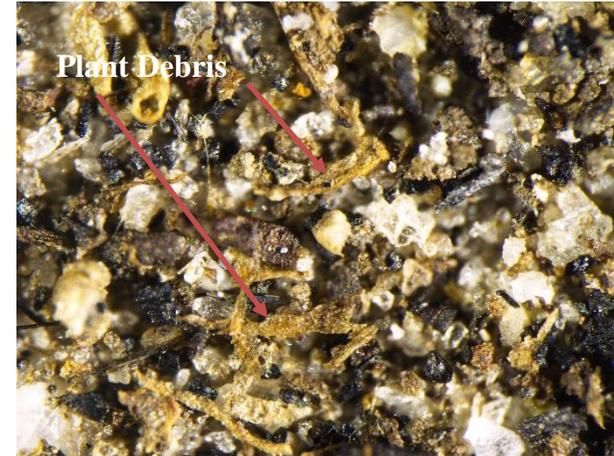
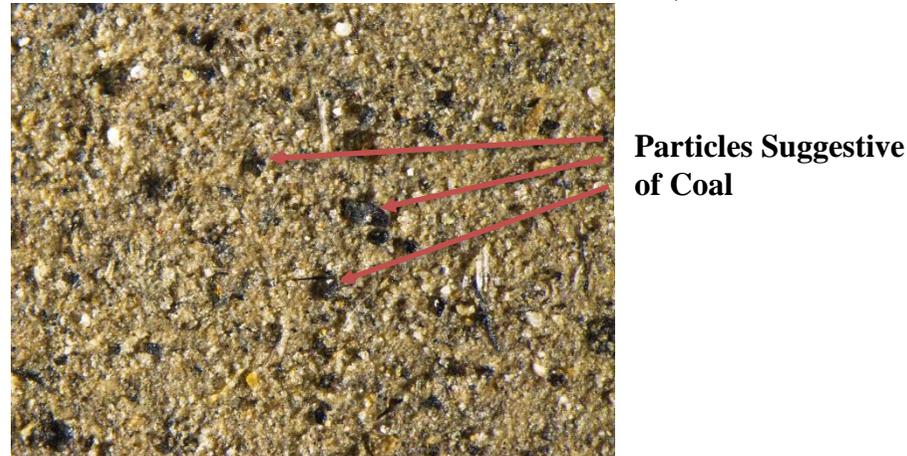
A. EHP S.V CV WETLANDS, UQMP # 14961. As Received Fraction.

B. EHP S.V CV WETLANDS, UQMP # 14961. Intermediate Fraction.

C. EHP S.V CV WETLANDS, UQMP # 14961. Fine Fraction.

All deposit fractions A, B and C display black sharp angular particulates consistent with the appearance of coal. A and B show coarse grained mineral dust particles with a range of colours from translucent, white, yellow to brown whilst C displays the same colour range with finer mineral dust particulates. The brownish yellow coloured, fibrous appearing particulates are suggestive of plant debris and small green filamentous algae is noted.

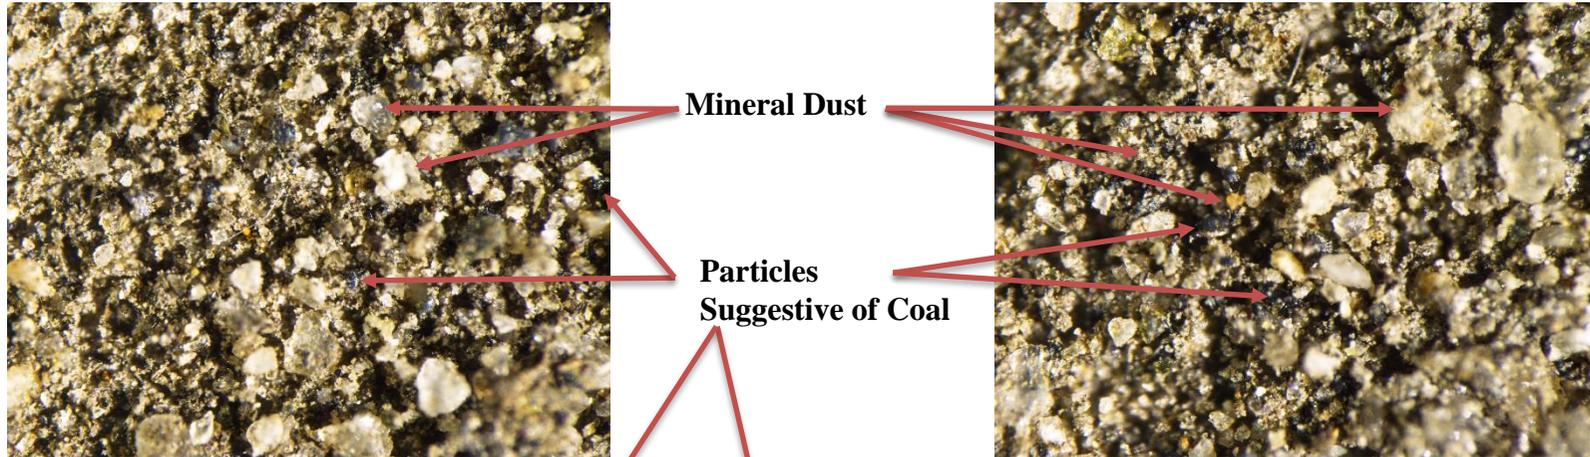
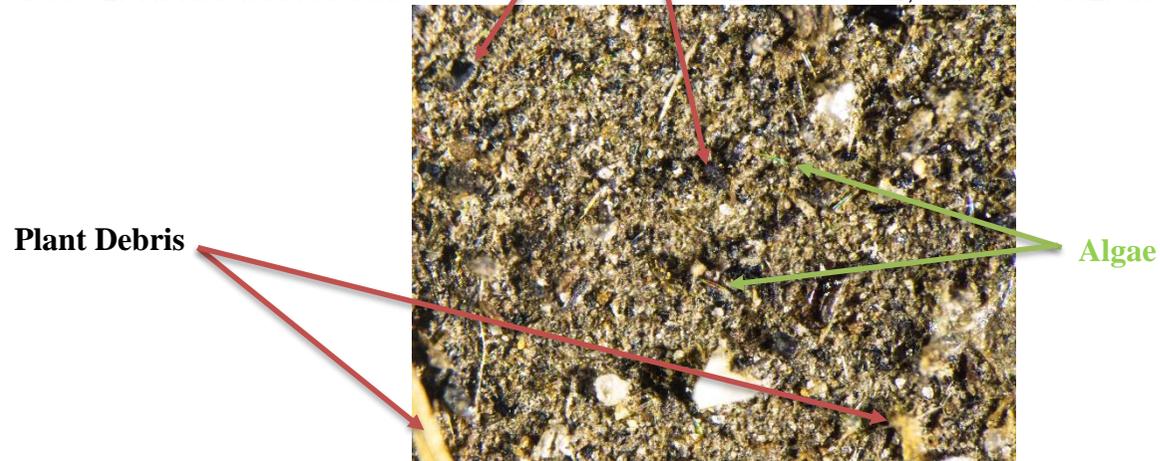
D. CV SHORE, UQMP # 14962. As Received Fraction.

E. CV SHORE, UQMP # 14962. Intermediate Fraction.

F. CV SHORE, UQMP # 14962. Fine Fraction.

Images D, E and F display coarse and fine grained mineral dust particles from translucent, white, yellow to brown. Black glossy angular particles suggestive of coal are scattered throughout all fractions of the deposit. Plant debris is noted in the fine fraction (F) and several filamentous algae particles are also present.

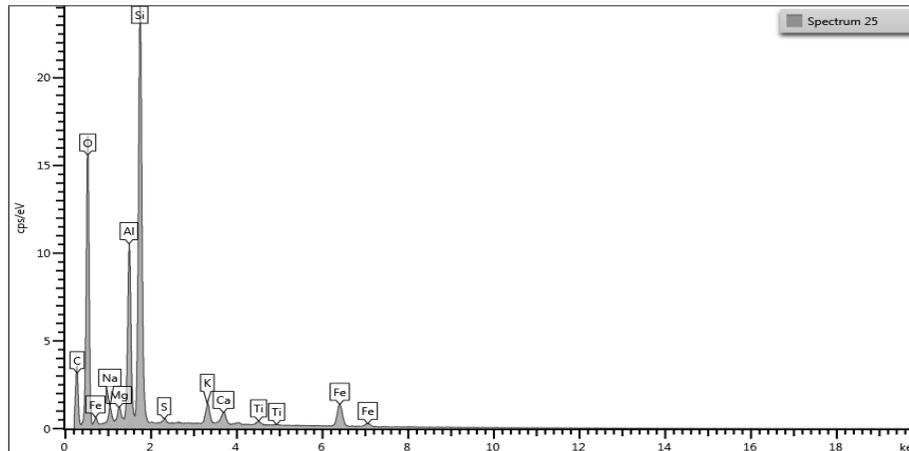
EDS1. EHP S.V CV WETLANDS, UQMP # 14961. The SEM/EDS spectrum of the overall area displays major peaks of oxygen, aluminium and silicon with minor amounts of carbon, sodium, potassium and iron and trace amounts of the balance of the elements. The SEM/EDS elemental profile is consistent with stereomicroscopy observations of the deposit consisting predominantly of mineral dust with a minor amount of organic material.

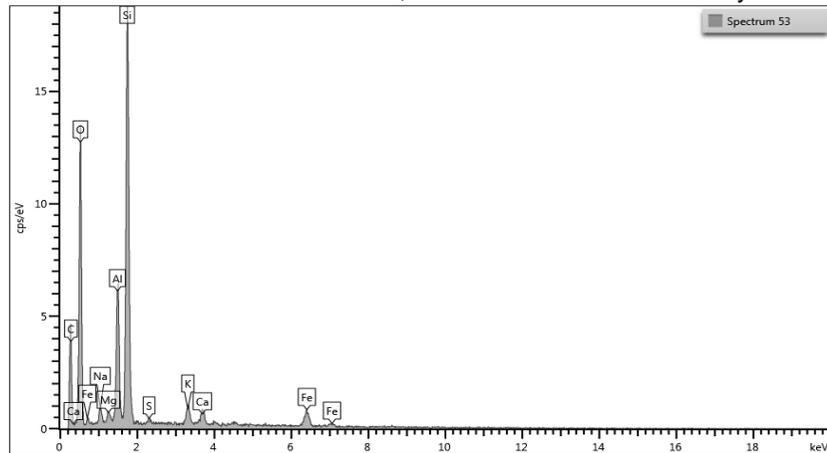
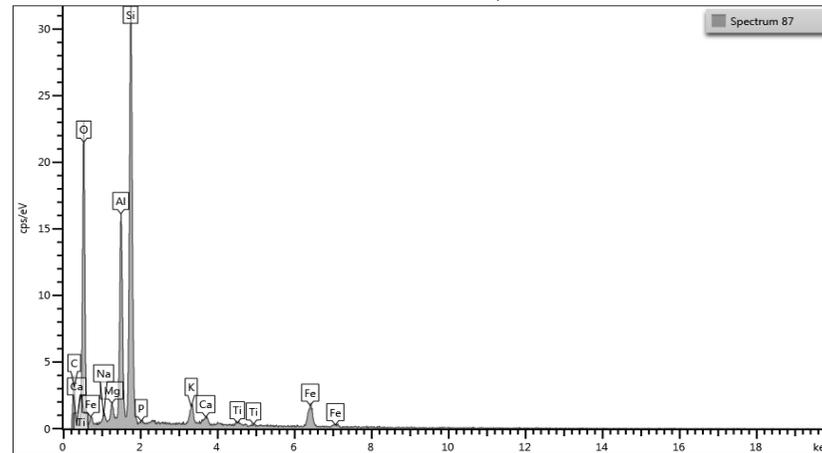
EDS2. EHP S.V CV WETLANDS, UQMP # 14961. The SEM/EDS spectrum of the overall area displays major peaks of oxygen, aluminium and silicon with minor amounts of carbon, sodium, potassium and iron and trace amounts of the balance of the elements. The SEM/EDS elemental profile is consistent with the sludge as received fraction.

EDS3. EHP S.V CV WETLANDS, UQMP # 14961. The SEM/EDS spectrum of the overall area displays major peaks of oxygen, aluminium and silicon with minor amounts of carbon, sodium, potassium and iron and trace amounts of the balance of the elements. The SEM/EDS elemental profile is consistent with the sludge as received fraction and intermediate fraction.

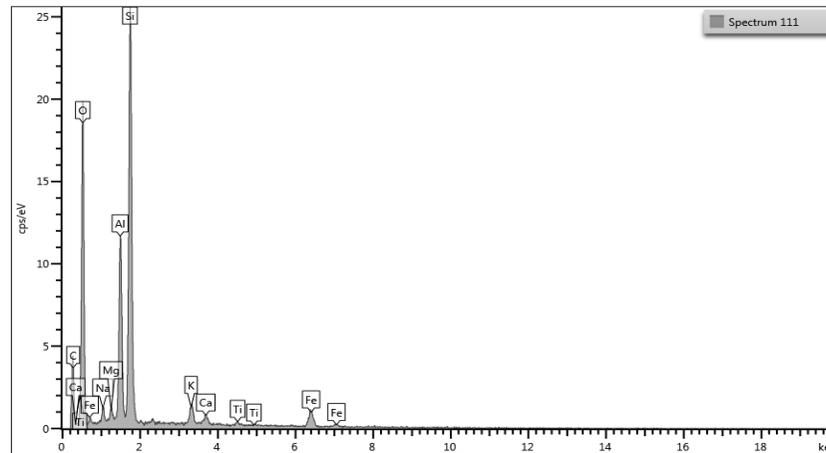
EDS4. CV SHORE, UQMP # 14962. As Received Fraction. The SEM/EDS spectrum of the overall area displays major peaks of oxygen, aluminium and silicon with minor amounts of carbon, sodium, magnesium, potassium and iron and trace amounts of the balance of the elements. This SEM/EDS elemental profile is consistent with the stereomicroscopy observations of a deposit consisting mostly of aluminosilicate based mineral dust with a minor organic component.

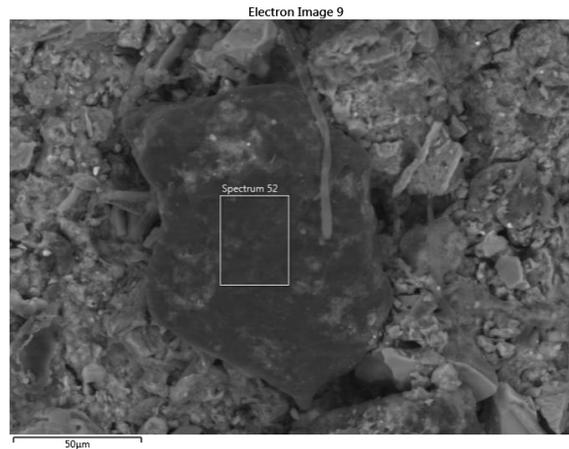
PM7. EHP S.V CV WETLANDS, UQMP # 14961. An SEM/BSE image of a coal particle annotated with Spectrum 52 selected for SEM/EDS analysis.

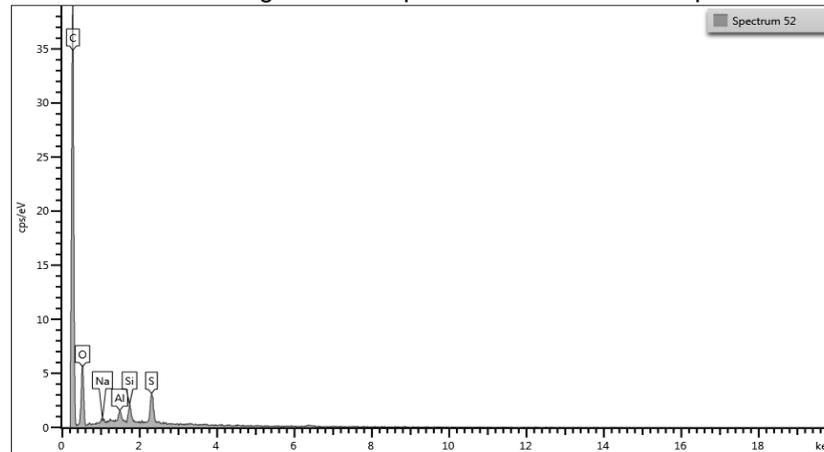
EDS7. EHP S.V CV WETLANDS, UQMP # 14961. Carbon is the major element of the SEM/EDS spectrum, with minor amounts of oxygen and sulfur and trace amounts of the balance of the elements, the elemental profile is characteristic of a low ash coal particle.
